**Flood Control Project Maintenance  
Levee Inspections**

**Fall 2018 Levee Maintenance Deficiency Summary Report**

**Flood Control Project Maintenance  
Levee Inspections****LMA District Cover Sheet****Fall 2018 Levee Inspection Results****Reclamation District No. 2096 Wetherbee Lake**

**Reclamation District No. 2096 Wetherbee Lake**

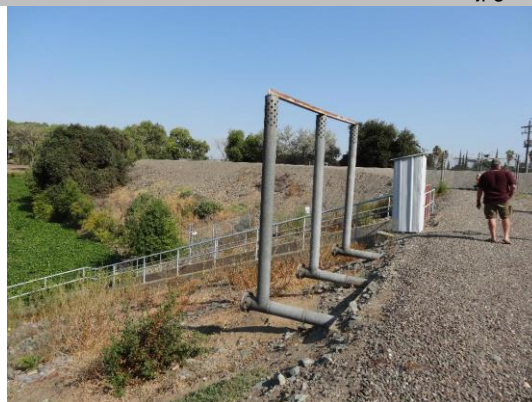
Photo 2 of 3 : UCIP\_FA\_2018\_21505\_36448.jpg

WS view: three air vents for three drainage pipes on levee shoulder.

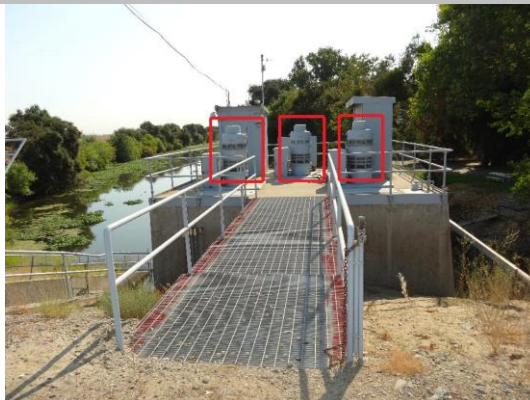
Photo 3 of 3 : UCIP\_FA\_2018\_21505\_36447.jpg

LS view: automatic pumping plant with three pumps. Steel walkway to pump platform.

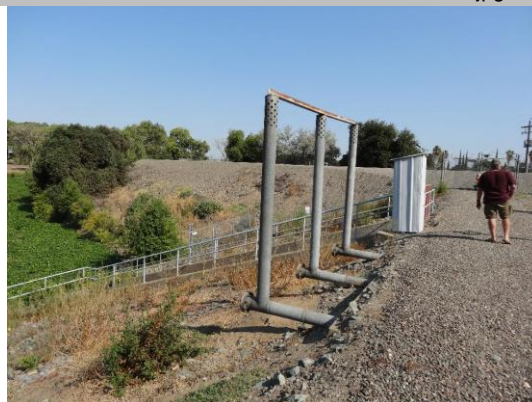
Photo 2 of 3 : UCIP\_FA\_2018\_21507\_36455.jpg

WS view: three air vents for three drainage pipes on levee shoulder.

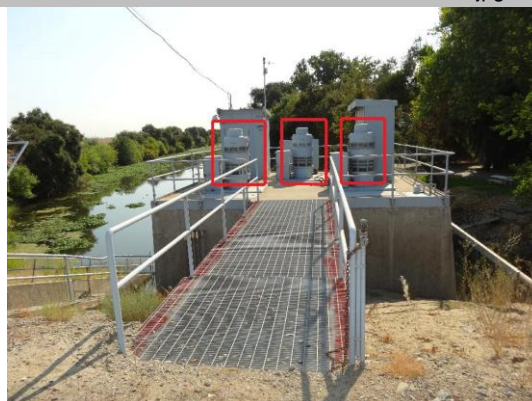
Photo 3 of 3 : UCIP\_FA\_2018\_21507\_36454.jpg

LS view: automatic pumping plant with three pumps. Steel walkway to pump platform.

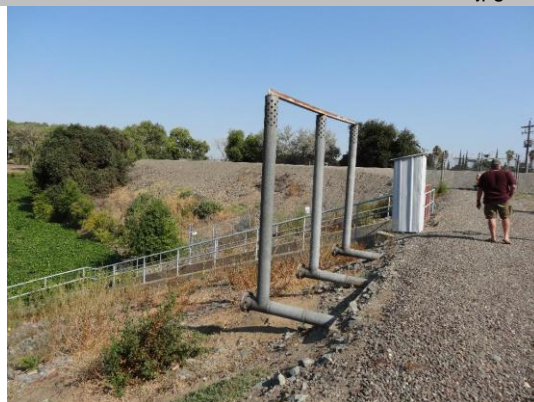
Photo 2 of 3 : UCIP\_FA\_2018\_21508\_36460.jpg

WS view: three air vents for three drainage pipes on levee shoulder.

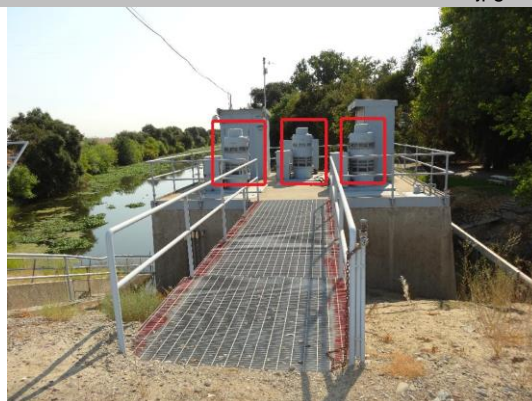
Photo 3 of 3 : UCIP\_FA\_2018\_21508\_36461.jpg

LS view: automatic pumping plant with three pumps. Steel walkway to pump platform.

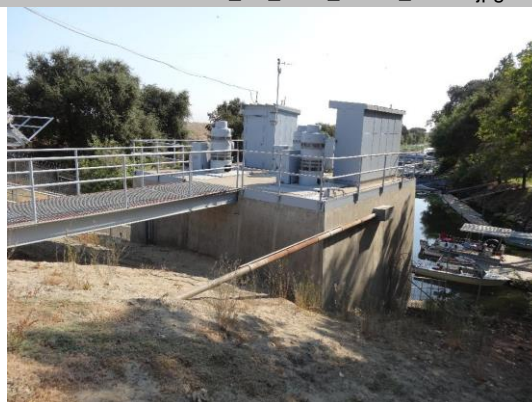
Photo 1 of 2 : UCIP\_FA\_2018\_21506\_36453.jpg

LM Start	0.03	Rating **	M	Issue No.	18	
LM End	0.03	Issue Type +	En	Location *		
Category	Supplemental			GPS Latitude/Longitude		
				Start	End	
Item	DWR UCIP Field Study			37.773800 °	37.773800 °	
				-121.298428 °	-121.298428 °	
DWR ID	24666					
Comment Code						
Inspector Comment						
FS_ID:21506 DS_ID:24666 EP_NO: N/A Repair Type: Non-Urgent Crossing Status: Found UCIP Comments: - more information needs to be find from LMA/DWR Inspector for this crossing. - needs to find whether this pipe passes through the levee. FIELD_STRUCT_DESC: 4-inch steel pipe of an unknown purpose through the levee and to the pump platform, 3 feet below the crown. It is an element of the pumping plant. Field study discovered utility crossing. FS Date: 9/10/2013

LS view: 4-inch steel pipe (right) through the levee and to pump platform.

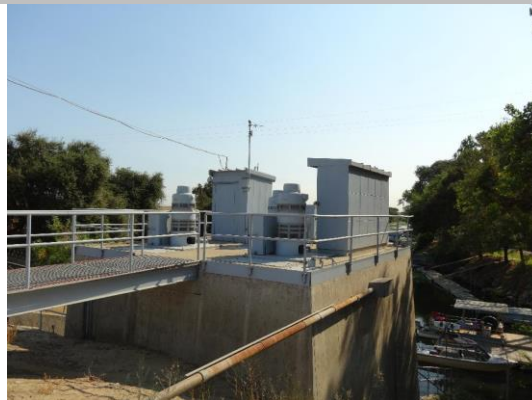
Photo 2 of 2 : UCIP\_FA\_2018\_21506\_36452.jpg

LS view: closer view of 4-inch steel pipe (left) through the levee and to pump platform.

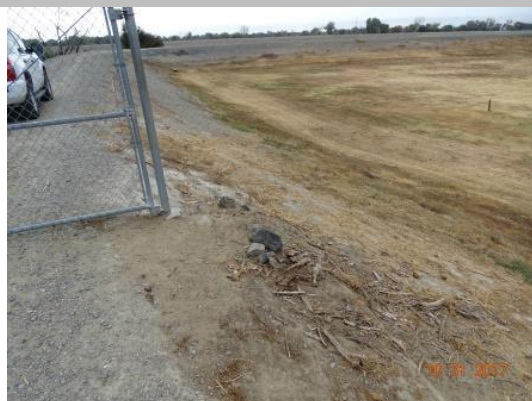
Photo 1 of 3 : FA\_2018\_RD2096\_117\_11\_20180906\_00004.jpg

View of the material placed to prevent vehicles from driving around the gate.

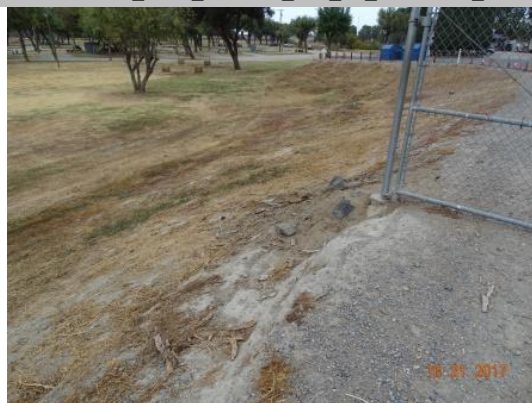
Photo 2 of 3 : FA\_2018\_RD2096\_117\_11\_20180906\_00005.jpg

Another view of the material placed to prevent vehicles from driving around the gate. Looking downstream.

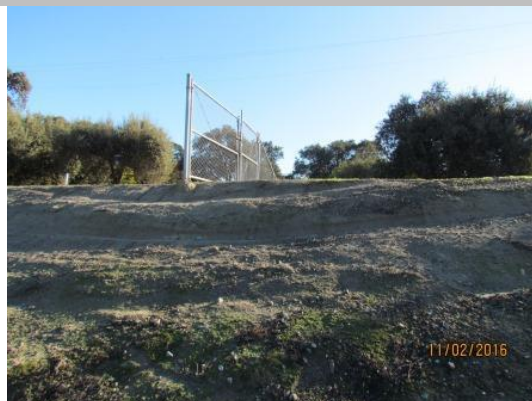
Photo 3 of 3 : FA\_2018\_RD2096\_117\_11\_20180906\_00006.jpg

LM Start	0.12	Rating **	M	Issue No.	11
LM End	0.12	Issue Type +	Ma	Location *	WS
Category	Earthen Levee			GPS Latitude/Longitude	
				Start	End
Item	Slope Stability			37.772434 °	37.772434 °
				-121.298433 °	-121.298433 °
DWR ID	DWR_RD2096_01_s_2015_11				
Comment Code					
S3 : Repair the levee slope damaged by vehicle traffic and prevent access where possible.					
Inspector Comment					
LMA restricted access but still a regrade and re-compaction of damaged waterside levee slope is required.

View of the waterside slope damaged by vehicle.
